MC17xx BSP 04.35.14 – Rev E release- Download Guide

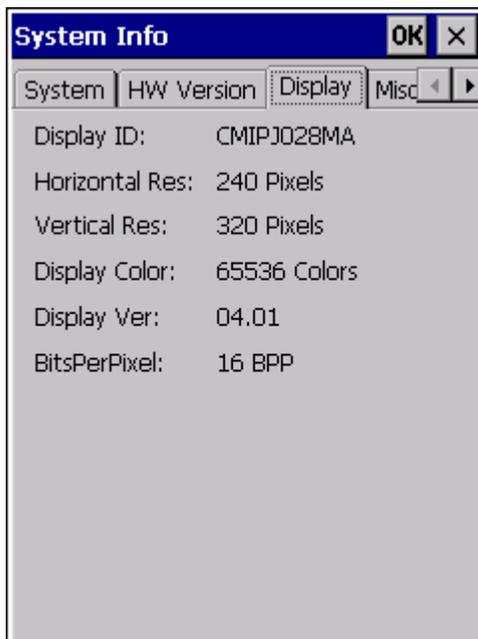
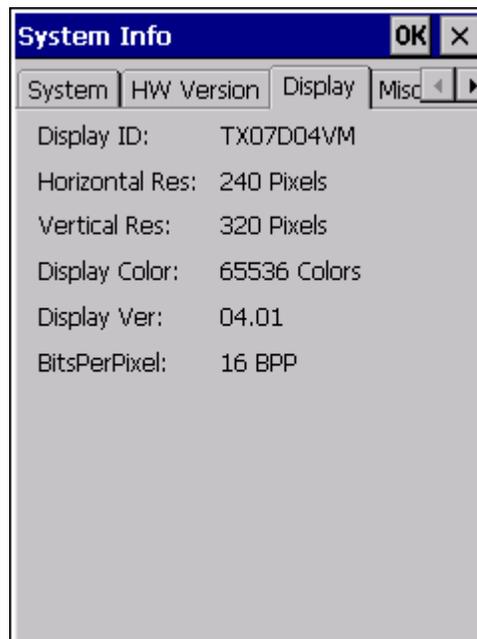
To identify, whether the device is a MC17U with CMI Display or MC17T/A with Hitachi Display, Go to Start Menu -> Settings -> Control Panel -> System Info -> Display Page.

If the Display ID is CMIPJ028MA, then it's a new MC17U device.

If it's TX07D04VM, then it's an old MC17A/MC17T device with Hitachi display.
