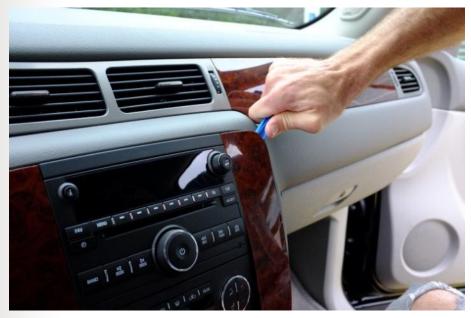
1) Carefully remove the trim panel as shown using trim panel removal tools to avoid damage.

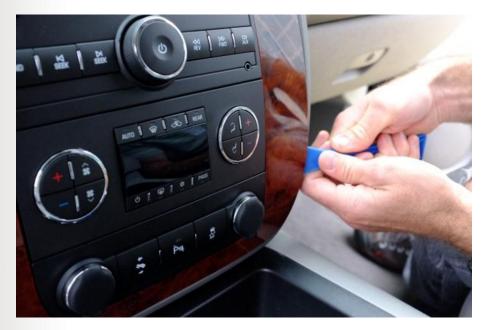
2) There are many retaining clips so work slowly all around the edges to release.

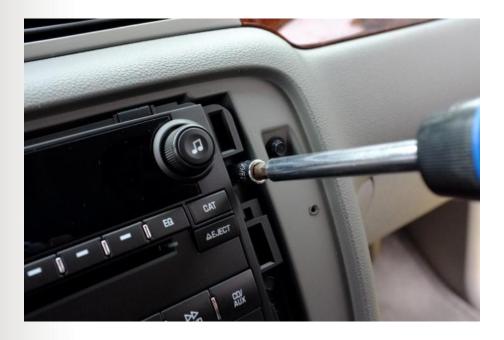
3) Remove the upper right radio retaining screw as shown.

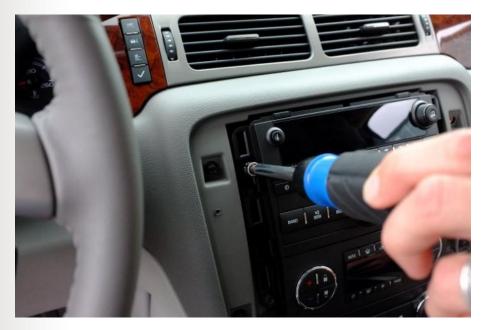
4) Remove the upper left radio retaining screw as shown.

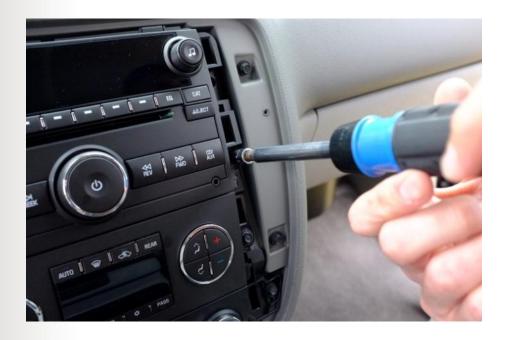
5) Remove the lower right radio retaining screw as shown.

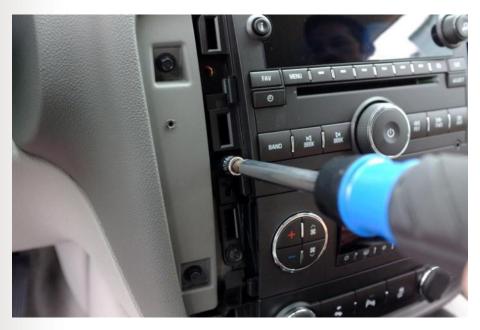
6) Remove the lower left radio retaining screw as shown.

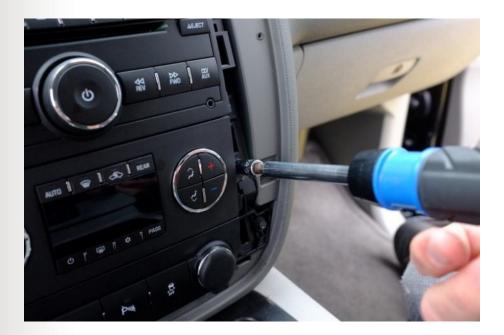
7) Remove both heater control retaining screws. Only right hand screw is pictured.

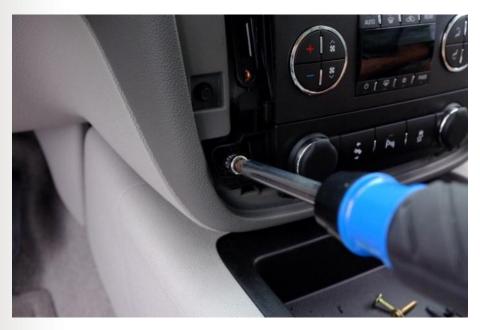
8) Remove both switch panel retaining screws. Only left hand screw is pictured.

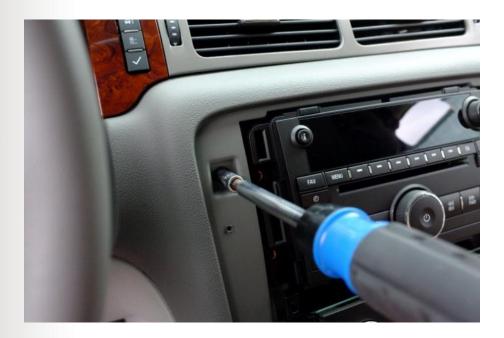
9) Remove the left hand fascia retaining screw as shown.

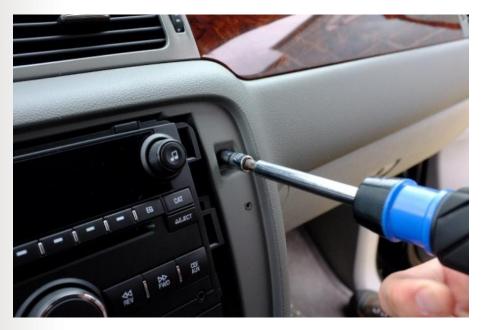
10) Remove the right hand fascia retaining screw as shown.

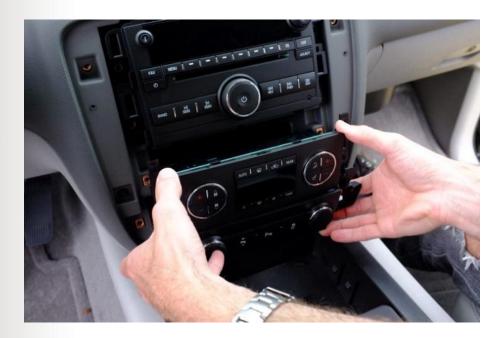
11) Remove the heater and switch panel units as shown.

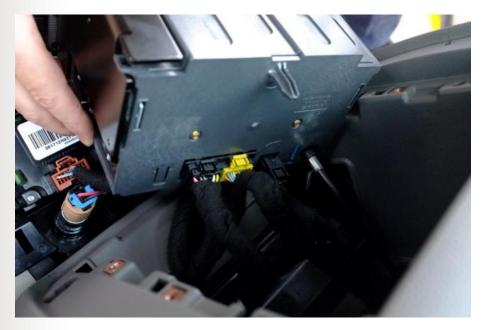
12) Remove the radio head unit disconnecting all of the wiring looms shown.

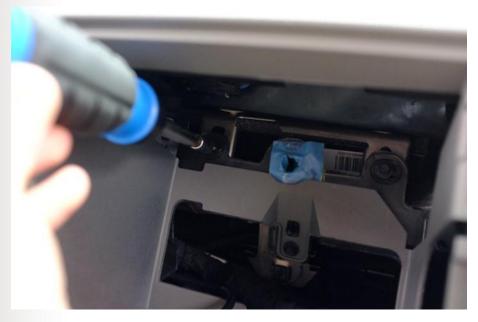
14) Remove the left hand chassis retaining bolt as shown.

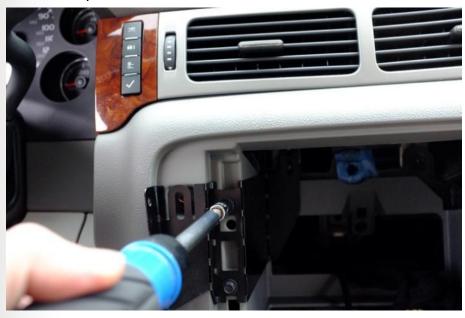
15) Fit the Left Hand Side Bracket 032-02-0301 as shown. Temporarily secure in place using two screws removed in steps 4 and 6.

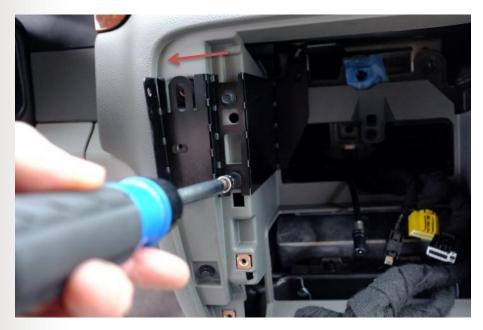
16) Ensure that the bracket is pushed firmly in the direction of the arrow as you tighten the screws.

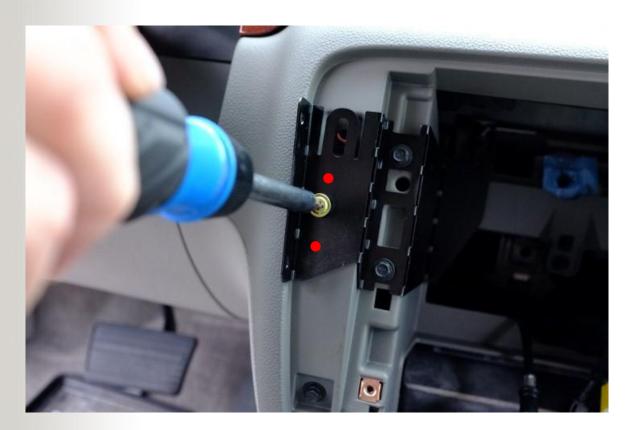
17) Fit two self tapping screws 039-02-0423 in the positions indicated in red below. Note that the picture below only shows one screw.

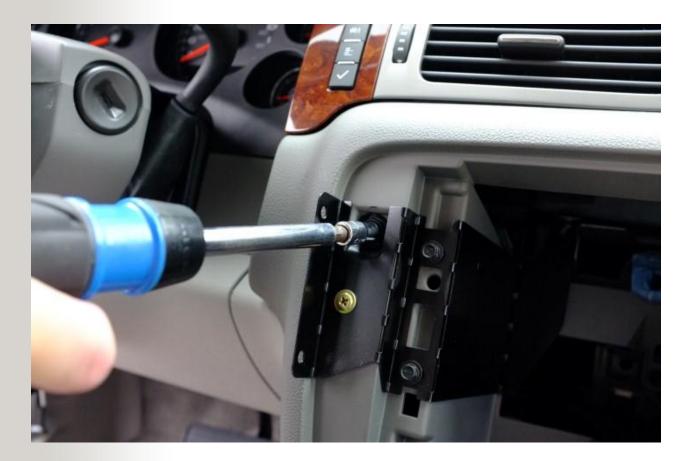
18) Fit the fascia retaining screw removed in step 9 as shown. Note that the metal of the bracket is designed to bend and will be pulled in by the screw. Ensure that it is fully tightened.

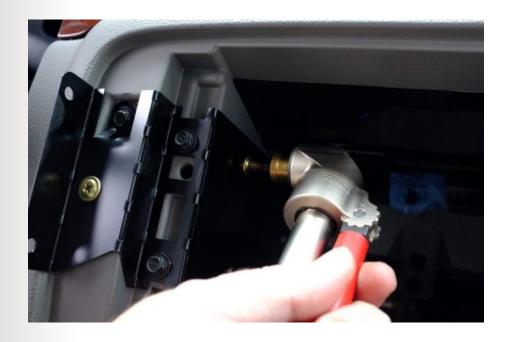
19) Fit one self tapping screws 039-02-0423 into the side as shown.

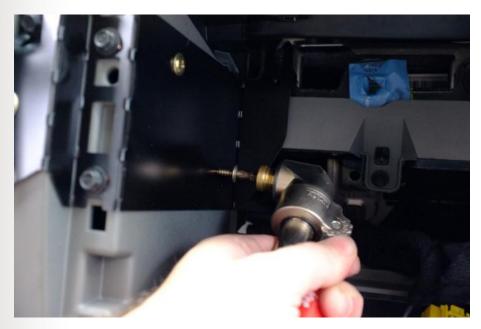
20) Fit one self tapping screws 039-02-0423 into the side as shown.

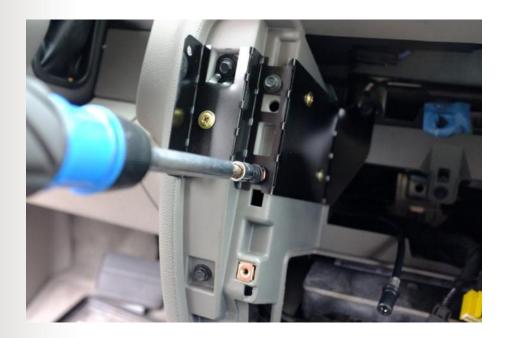
23) Remove the lower screw which was temporarily fitted in step 15.

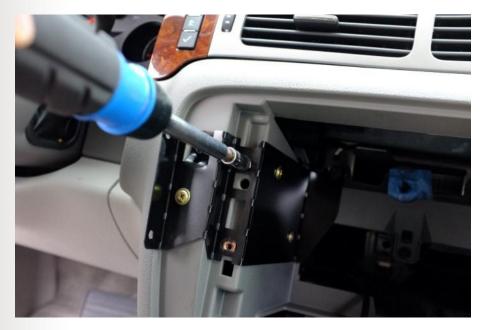
24) Remove the upper screw which was temporarily fitted in step 15.

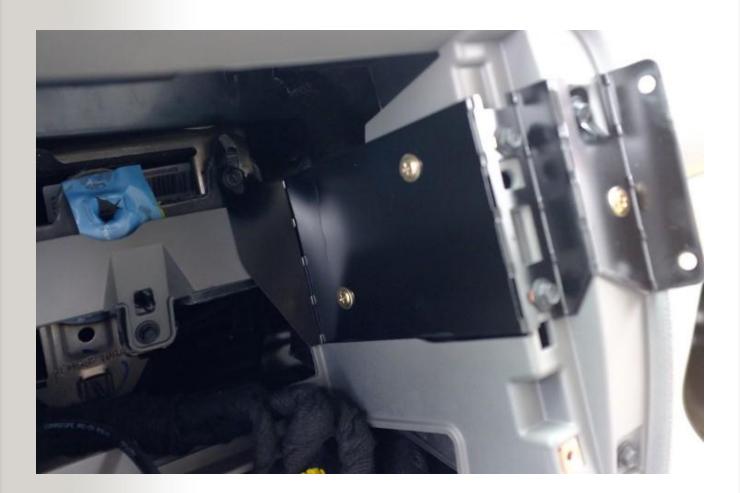
25) Repeat steps 15 to 24 for the Right Side Bracket 032-02-0300 pictured below.

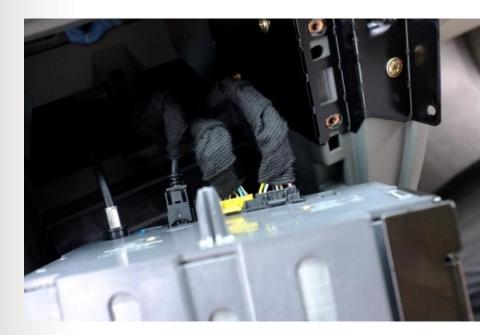
26) Replace the cable looms removed in step 12 and refit the radio head unit.

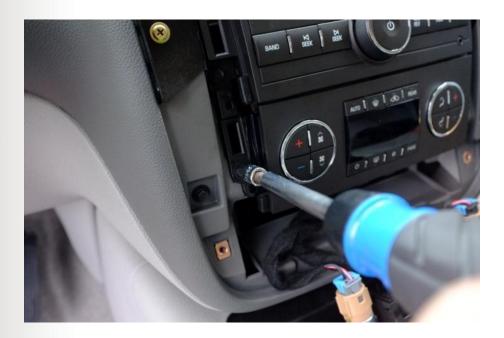
28) Refit the heater control unit and secure with the left hand retaining screw as shown.

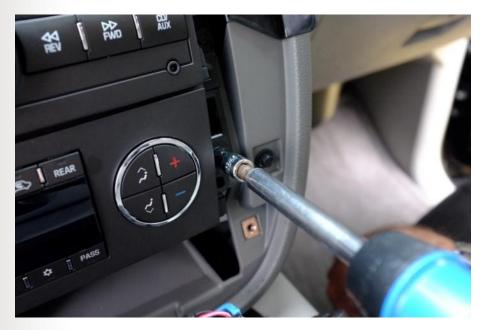
29) Refit the right hand retaining screw to the heater control unit as shown.

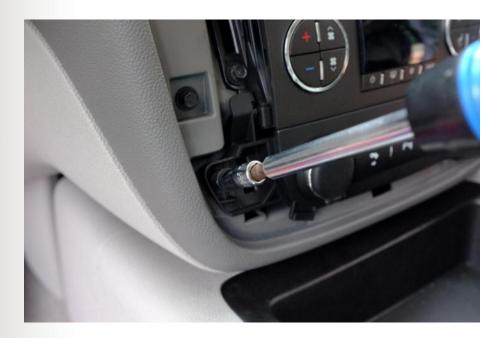
30) Refit the switch panel unit and secure with the left hand retaining screw as shown.

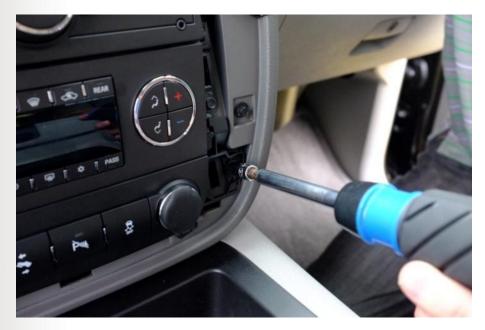
31) Refit the right hand retaining screw to the switch panel unit as shown.

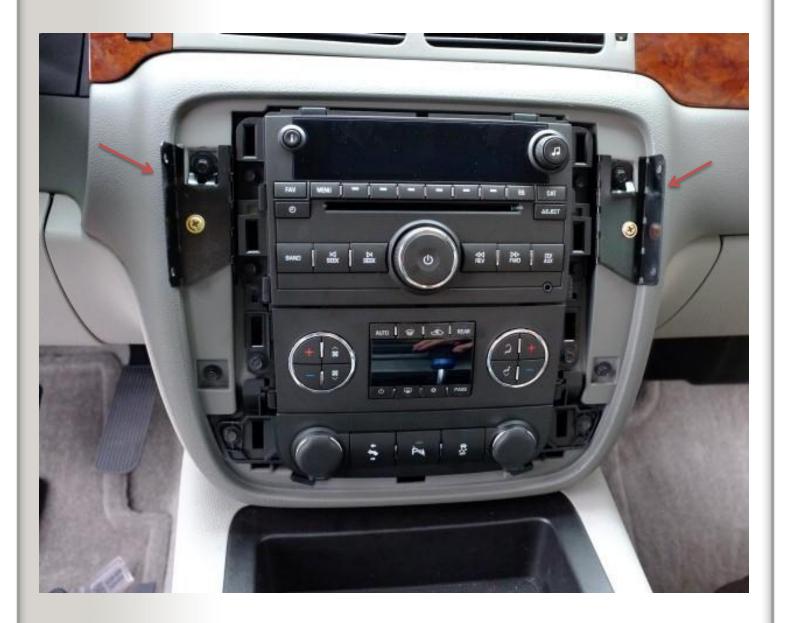
32) The vehicle should now look like the below photograph and is ready to have the trim panel refitted.

Note that it may be necessary to bend out the two metal tabs indicated slightly to make fitting of the trim panel easier.

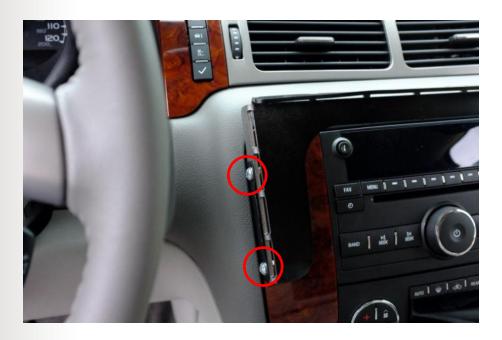
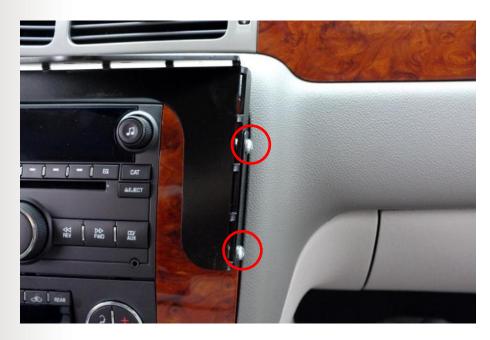
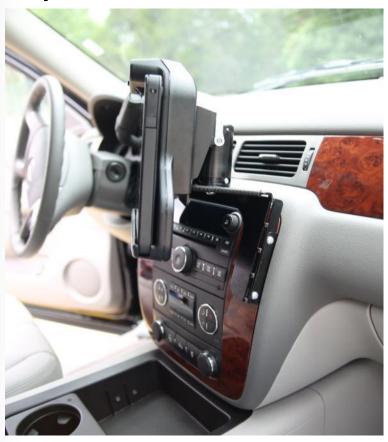
33) Once the trim panel is securely back in place, fit the Front Bracket 032-02-0299 as shown.

Use four screws TD503712 and four lock washers TD503481 in the positions shown and tighten securely.
