Kiosk TTP 2100 Firmware Downgrade

Instructions from version 3.96 or later, to an earlier version

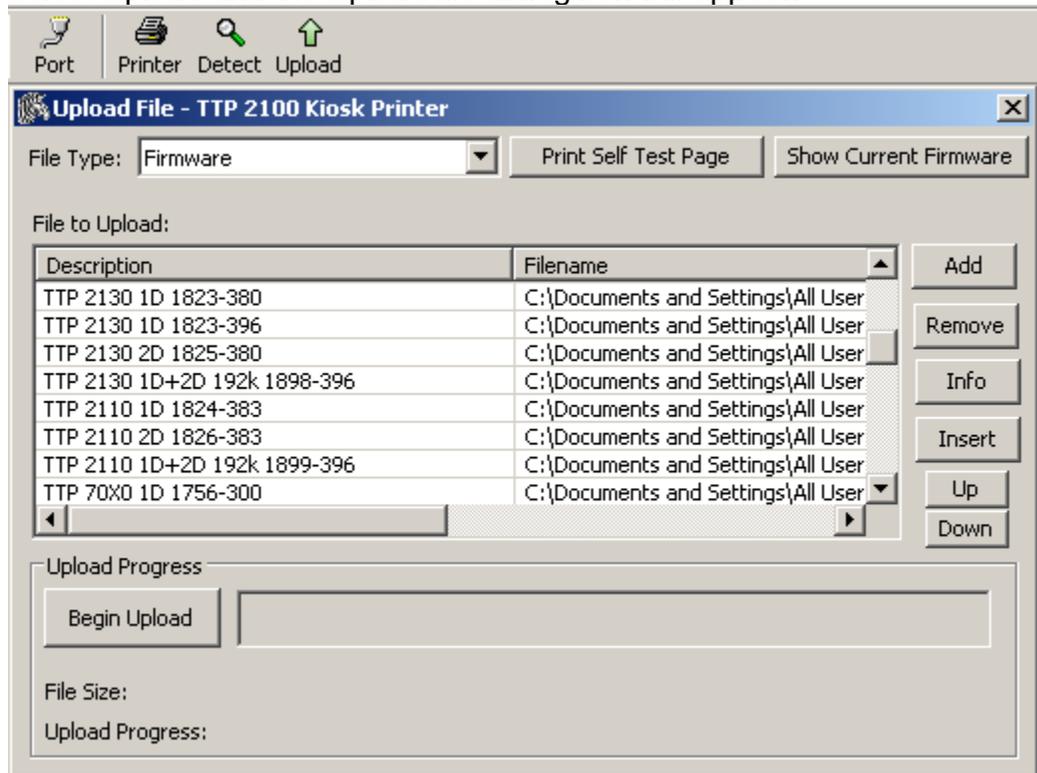
- Select Upload and the Upload file dialog box will appear.

- Select Print Self Test Page to print a receipt with the current parameter settings.
- Select the 1D-firmware appropriate for the printer you are upgrading from the File to Upload list.
 - If the firmware is not available on the list, it needs to be added. The firmware files are contained within the zip file on the Zebra website. Select Add and browse to the file location for the SPI firmware. Name the file and select Open.
- Select Begin Upload. The status light on the printer will flash rapidly when the firmware is being written to the Flash PROM². Wait until you hear the presenter motor click before selecting OK in the popup window. The sound will signify the file is written properly.
- Auto calibrate the media to the printer
- Select Print Self Test Page to print a receipt to verify the firmware version.

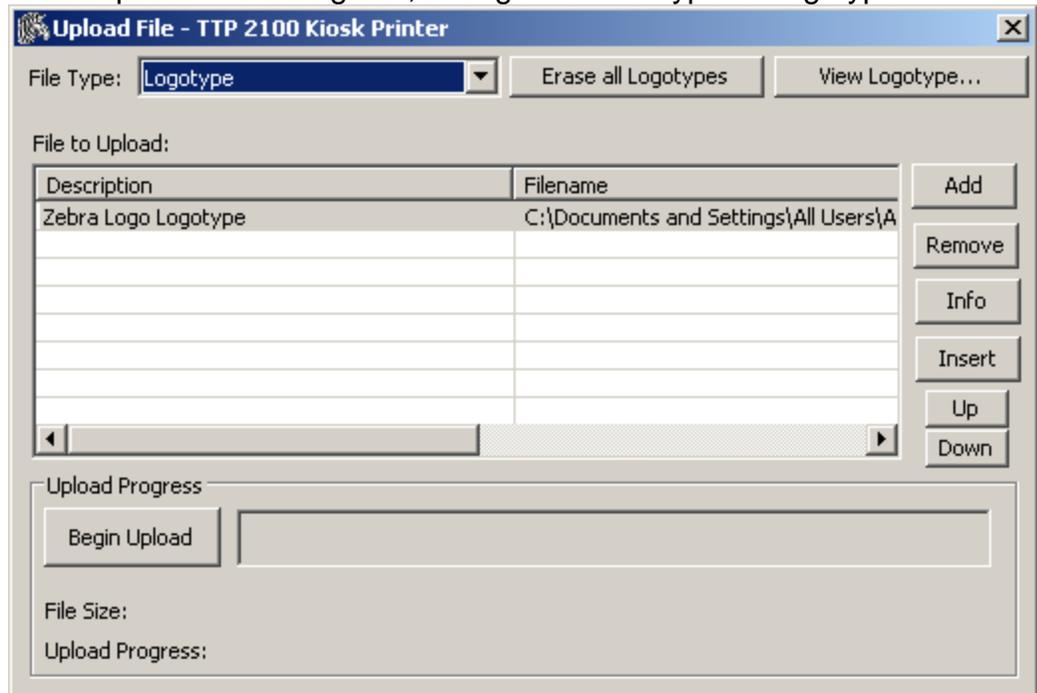
- In the Upload File dialog box, change the File Type to Logotype.

- Select “Zebra Logo Logotype” and click “Begin Upload”. The status light on the printer will flash rapidly when the logotype is being written to the Flash PROM. Wait until you hear the presenter motor click before selecting OK in the popup window. The sound will signify the file is written properly.
- If any other logos need to be added;
 - Select Add and browse to the file location for the logo. Name the file and select Open.
 - Begin Upload, following the instructions in the step above.
 - Repeat the process until all logos are loaded in the proper order.

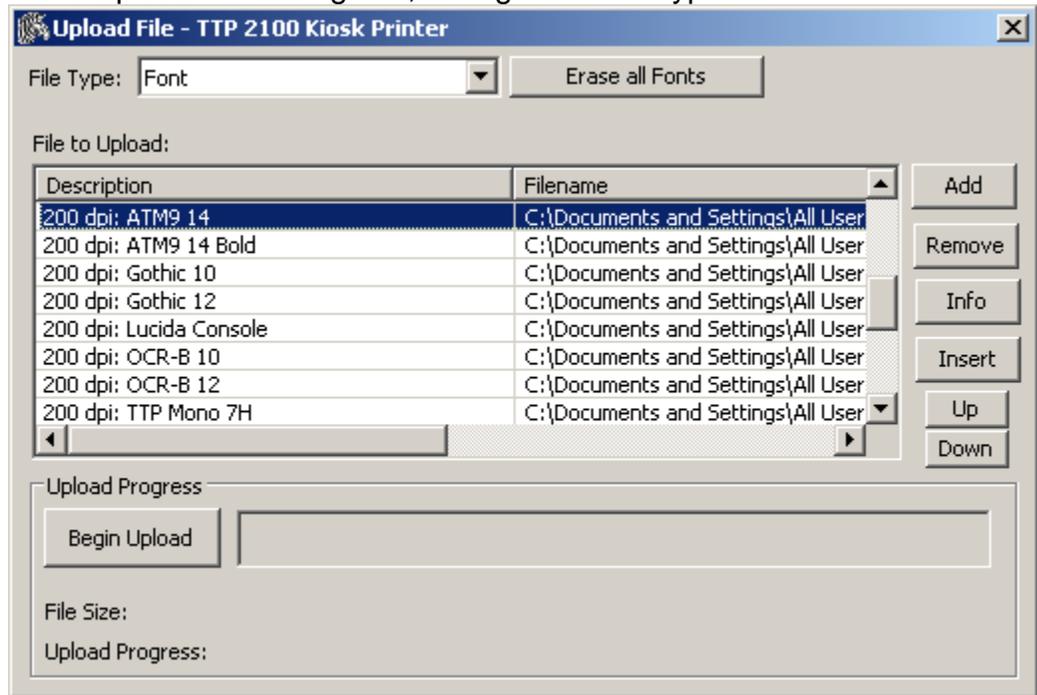
- In the Upload File dialog box, change the File Type to Font.

- The Zebra fonts are already included with Toolbox. It is important to pick the fonts in the right order:
 - Select 200 dpi: ATM9 14. Select Begin Upload. The status light on the printer will flash rapidly when the firmware is being written to the Flash PROM. Wait until you hear the presenter motor click before selecting OK in the popup window. The sound will signify the file is written properly.
 - Select 200 dpi: OCR-B 10 and Upload.
 - Select 200 dpi: OCR-B 12 and Upload.
 - Select 200 dpi: Gothic 10 and Upload.
 - Select 200 dpi: Gothic 12 and Upload.
- If any other fonts need to be added;
 - Select Add and browse to the file location for the font. Name the file and select Open.
 - Begin Upload, following the instructions in the step above.
 - Repeat the process until all fonts are loaded in the proper order.

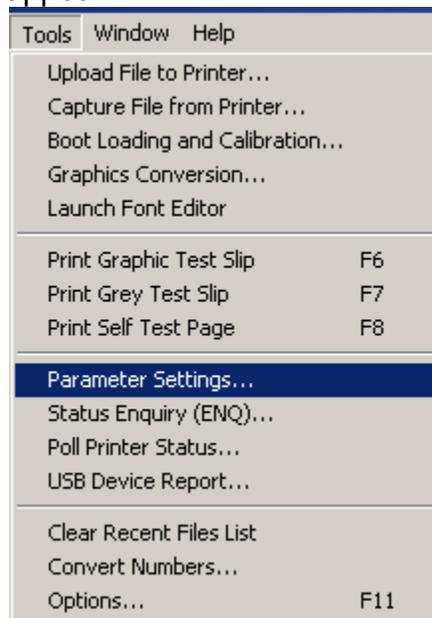
- Stop the spooler and start Toolbox as described on page 3.
- Under the Tools heading, select Parameter Settings and a dialog box will appear.

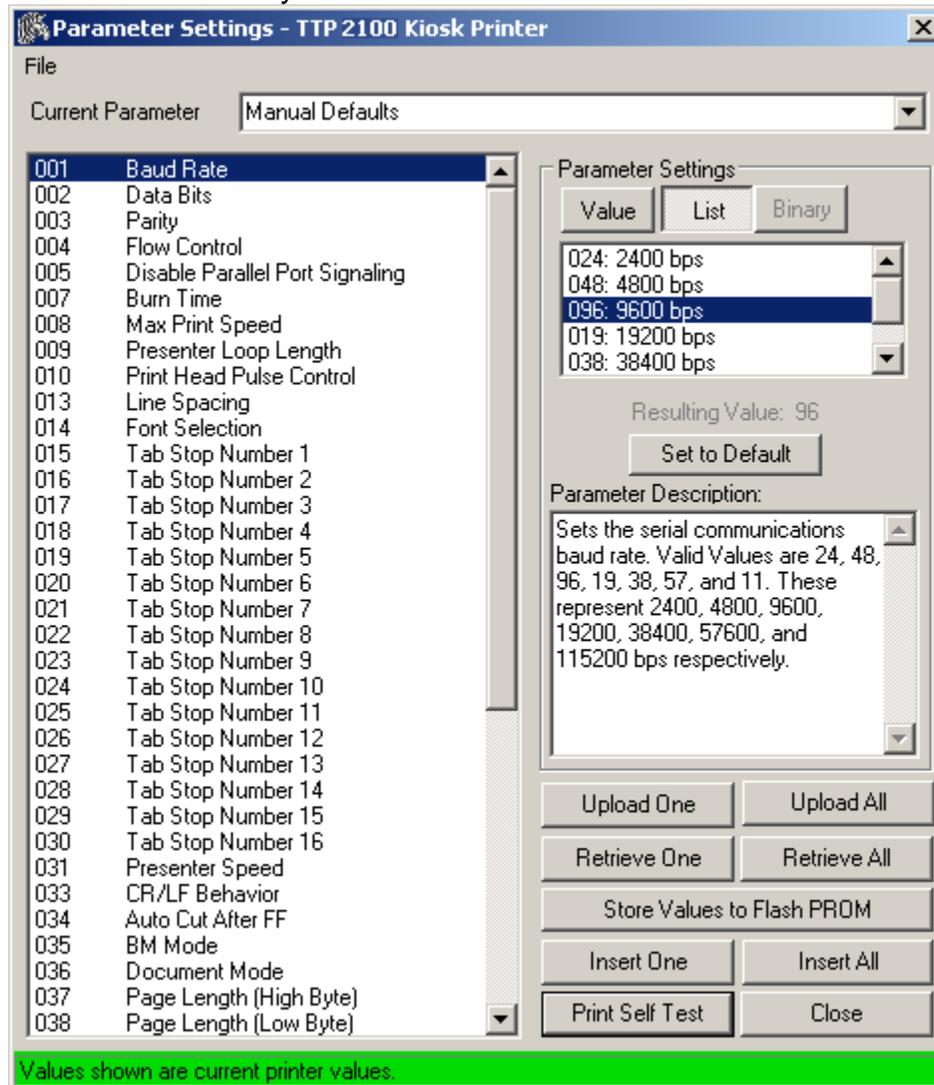
- Make sure the bottom bar is highlighted in green to ensure the printer parameters are properly read from the printer. If not green, select “Retrieve All” to retry.

- Select the parameter to change. One can either select the parameter value from the list, or one can enter the value directly by selecting the Value button.
- After all values have been changed, select Upload All.
- Print a Self Test Page. All changed values will be preceded by an asterisk. This makes it easy to see the values changed.
- Select Store Values to Flash PROM. This makes the values persistent through a power cycle. The presenter motor will click to verify the values are stored.
- Close Toolbox and enable the print spooler as described on page 7.
